Depleted Uranium in Kosovo

Post-Conflict Environmental Assessment

UNEP Scientific Mission to Kosovo
5 – 19 November 2000

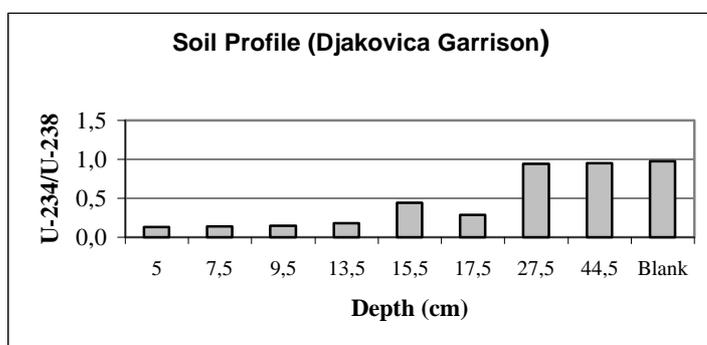
Figure 7.1 U-234/U-238 ratio in soil profile at site of DU penetrator, Gjakove/Djakovica garrison

The total activity of the DU contamination at and below the level of the penetrator was about 150 kBq, equivalent to 12 g of DU. That means that the penetrator had lost about 4 % of its total mass (initially about 300 g) at the time of impact and subsequently (over a period of 1.5 years) by dissolution. The soil profile in terms of the ratio U-234/U-238 is shown in Figure 7.1 below.

The results from the other laboratory are shown below in Table 7.2 and refers to samples UNEP 082 – 090. The high values in Table 7.2 are caused by a DU fragment in the soil. Note: the laboratory did not take part in the quality control exercise (NAT-9).

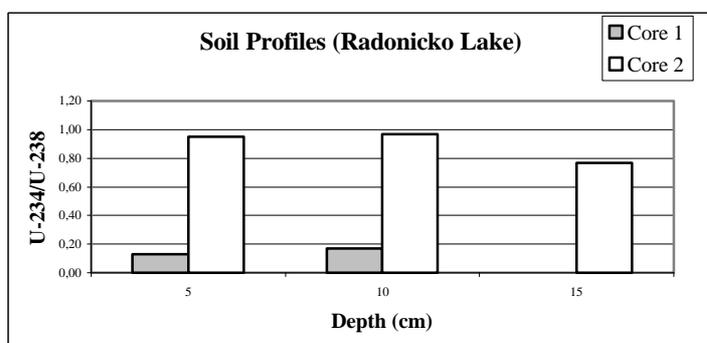
Figure 7.2 Distribution of U-234/U-238 activity ratios in soil profiles at Radonicko lake

It is concluded from Table 7.4 and Figure 7.2 that DU is present to a level of almost 100 % in both samples from core 1 (i.e. from immediately below the penetrator) but not in any significant amount in samples from core 2 (1.5 m away from a penetrator hole). The activity concentration decreases by a factor of five to seven between 0 – 5 cm depth and 5 – 10 cm depth below the penetrator.

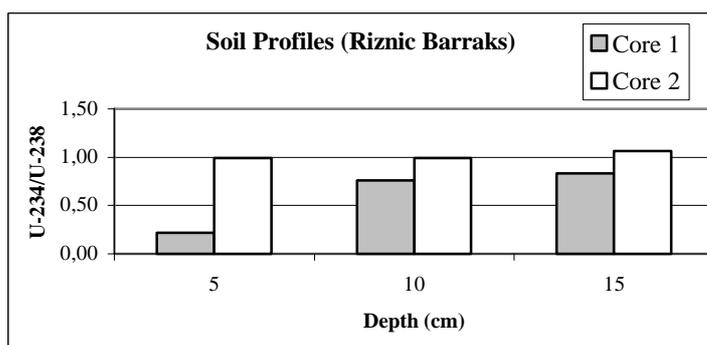
Figure 7.3 Soil Profiles (Irzniq/Riznic Barraks)

In other soil samples taken close to the underground concrete water tank (UNEP 146 – 151) there was a strong indication of DU (70-80 % DU) in the sample taken at 0 – 5 cm depth and a weak indication (15-20 % DU) at 5 – 15 cm depth. The total uranium concentration in the upper 5 cm was 11 – 13 mg/kg, or about 4 times the normal natural uranium concentration.
